Program Bulletin

CUSTOMER SATISFACTION PROGRAM

SUBJECT: PAINTED ROOF ADHESIVE SEPARATION

**MODELS: 2005-2006 CHEVROLET CORVETTE
WITH PAINTED ROOF**

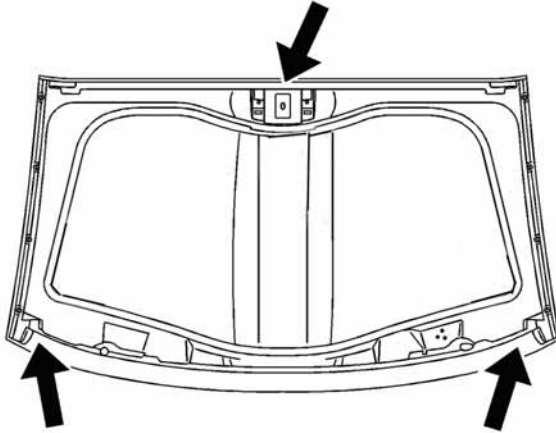
1841578

9. Inspect for proper adhesion by inserting a 0.254 mm (.010 in) feeler gage between the panel and the frame. If the feeler gage fits between the panel and the frame, and the depth is 19.05 mm (.750 in) or greater, the roof panel is separated from the frame.
- If the feeler gage does not identify any area of the roof panel with separation, proceed to Step 4.

- If less than 75 percent of the roof panel is separated from the frame, prepare the roof panel for the foam adhesive injection procedure. Refer to the section titled, *Roof Panel Preparation for Roof Panels with Separation*. This is a temporary repair that will prevent the separation of the roof panel. Submit the claim using labor code T5461, which will not close the program in GMVIS. When the roof panel is available, install the new roof panel and submit the claim using the appropriate V labor code, which will close the program in GMVIS.

- If more than 75 percent of the roof panel is separated from the frame, replace the roof panel.
