Program Bulletin

CUSTOMER SATISFACTION PROGRAM

SUBJECT: PAINTED ROOF ADHESIVE SEPARATION

**MODELS: 2005-2006 CHEVROLET CORVETTE
WITH PAINTED ROOF**

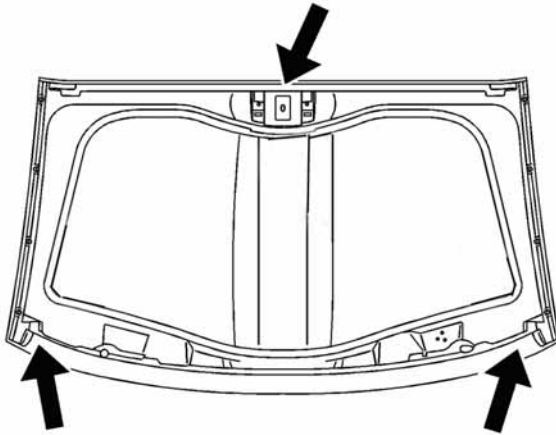
1841578

9. Inspect for proper adhesion by inserting a 0.254 mm (.010 in) feeler gage between the panel and the frame. If the feeler gage fits between the panel and the frame, and the depth is 19.05 mm (.750 in) or greater, the roof panel is separated from the frame.

- If the feeler gage does not identify any area of the roof panel with separation, proceed to Step 4.
 - If less than 75 percent of the roof panel is separated from the frame, prepare the roof panel for the foam adhesive injection procedure. Refer to the section titled, *Roof Panel Preparation for Roof Panels with Separation*. This is a temporary repair that will prevent the separation of the roof panel. Submit the claim using labor code T5461, which will not close the program in GMVIS. When the roof panel is available, install the new roof panel and submit the claim using the appropriate V labor code, which will close the program in GMVIS.

- If more than 75 percent of the roof panel is separated from the frame, replace the roof panel.

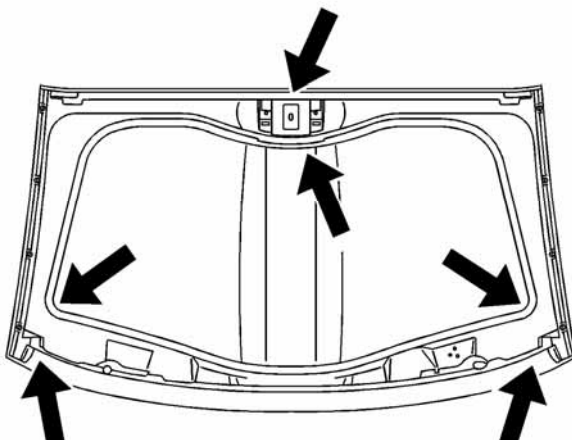
1748402

4. Inspect for proper adhesion by inserting a 0.254 mm (.010 in) feeler gage between the panel and the frame. Particular attention should be paid to the areas around the rear latch and the front corners. If the feeler gage fits between the panel and the frame, and the depth is 19.05 mm (.750 in) or greater, the roof panel has some degree of separation.
 - If the feeler gage does not identify any area of the roof panel with separation, proceed to Step 5.

- If less than 75 percent of the roof panel is separated from the frame, prepare the roof panel for the foam adhesive injection procedure. Refer to the section titled, *Roof Panel Preparation for Roof Panels with Separation*. This is a temporary repair that will prevent the separation of the roof panel. Submit the claim using labor code T5641, which will not close the program in GMVIS. When the roof panel is available, install the new roof panel and submit the claim using the appropriate V labor code, which will close the program in GMVIS.

- If more than 75 percent of the roof panel is separated from the frame, replace the roof panel. The SI procedures below may be used.
